Tailhook vs. Finger

By LCpl. Brandon Fitzhugh

Simple Brass Ring

By AD2(AW) Nicholas Rafanello

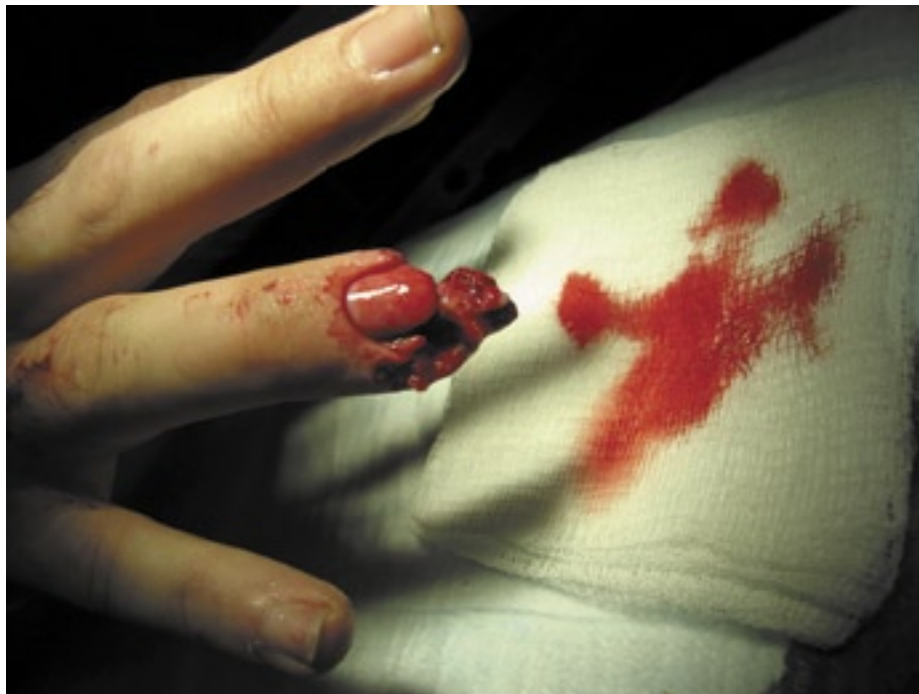
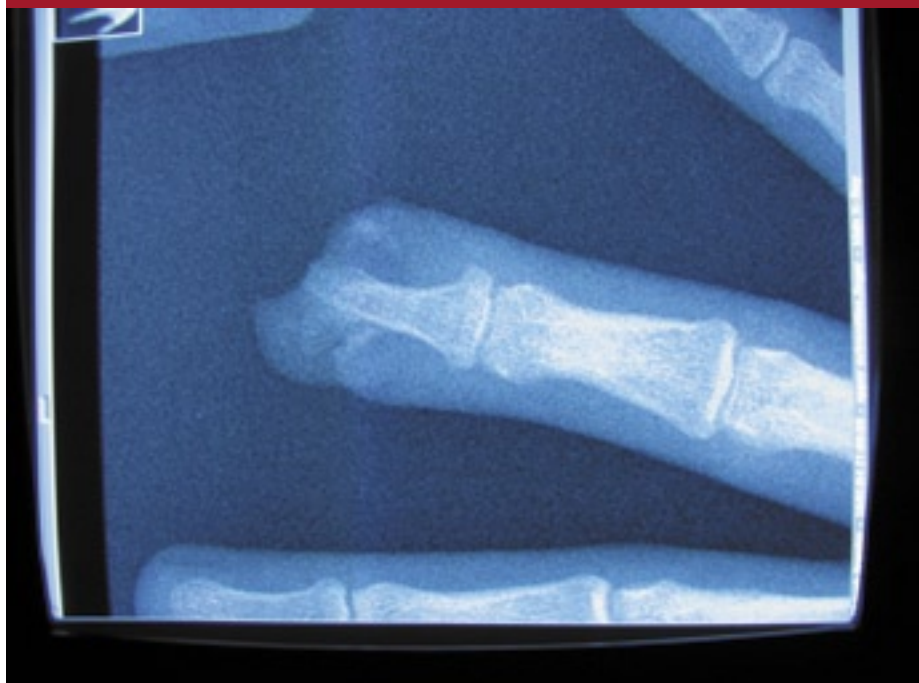
As I crawled under the aircraft, I saw the hook begin to raise. I quickly signaled the yellowshirt to drop it again. As I rushed to get back under the jet, I lost my balance, and the worst thing happened: The yellowshirt never signaled to re-drop the hook, so it continued to come up. Unable to stop my momentum, I grabbed the hook. My hand came up with the hook, and my ring finger was compressed between the stop pad and the shaft.

The yellowshirt then began to taxi the aircraft with me still attached!

I yelled and tried to signal for help, but no one noticed my situation. The yellowshirt then began to taxi the aircraft with me still attached! In fear of being dragged across the flight deck, I quickly pulled myself free. However, that action resulted in the amputation of the last inch of my left ring finger.

As a result of this incident, I learned two key lessons. First, communication always is a key function when operating in a crew environment. Without visual or verbal cues, chaos, complacency, and assumptions will occur. Lastly, **never** touch any moving parts of an aircraft, unless everyone knows you're doing it. I learned the hard way and now have a constant reminder of how a couple simple steps could have prevented a personal nightmare. ✈
